Use Attainability Analysis

WBID 0737 Cedar Creek

Submitted by  
SES, Inc.

**Field Data Sheets for Recreation Use Stream Surveys**  
**Data Sheet A - Water Body Identification**  
(For water body being surveyed)

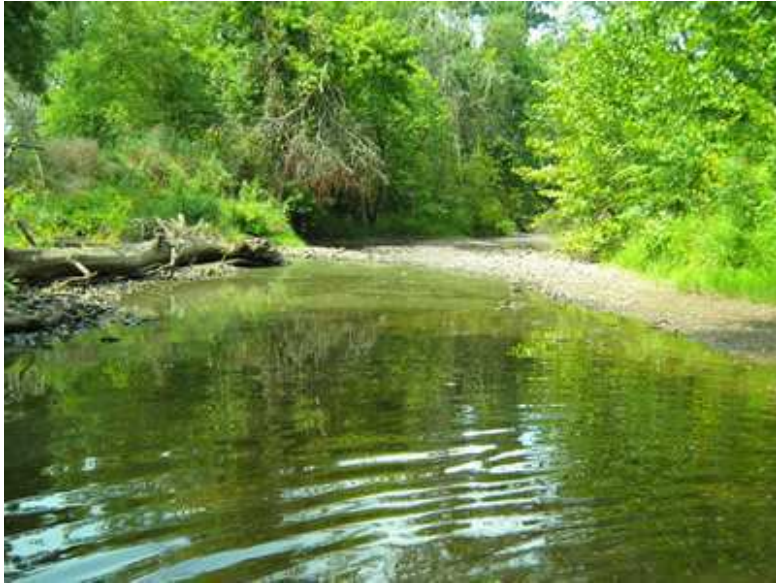
**Site# 1 Photo ID# 1, Upstream**

**WBID #** 737      **Site #** 1  
**Mark #** 76      **Dissolved Oxygen (ppm)** 6.9  
**Upstream Views Physical Dimensions:** Is there any water present at this view? yes

If so, is there an obvious current? no

% of Channel Feature				
Riffle	0				
Run	0				
Pool	100

15%-30% prairie forbs and grasses on one transect all growing out from bank into low water depth areas of channel.

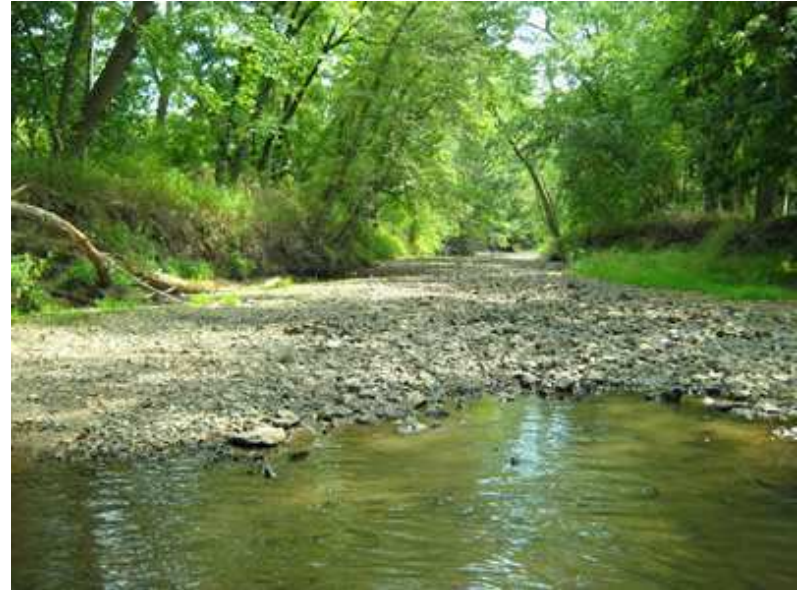
**Site# 1 Photo ID# 2, Downstream**

**Downstream View's Physical Dimensions:** Is there any water present at this view? yes

If so, is there an obvious current? no

% Cobble	% Gravel	% Sand	% Silt
61	11	28	0
% Mud/Clay	% Bedrock		
0	0

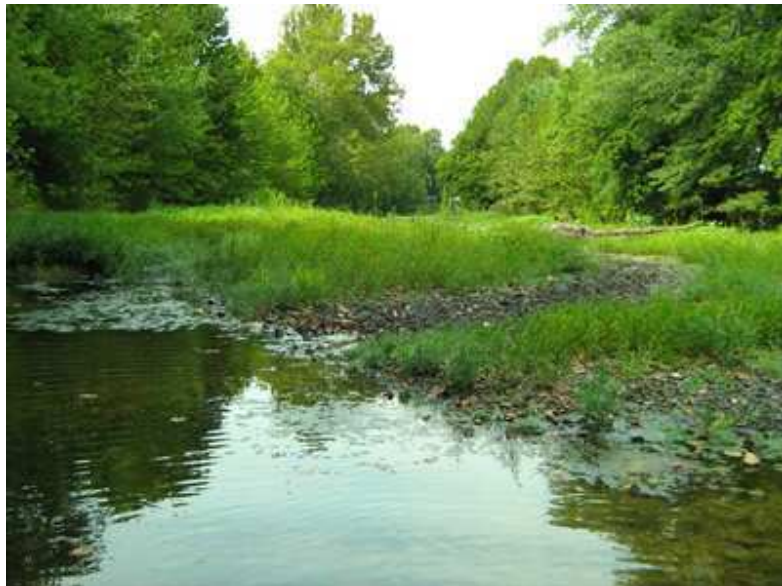
**Site# 2 Photo ID# 4, Upstream**

**WBID #** 737      **Site #** 2  
**Mark #** 77      **Dissolved Oxygen (ppm)** 7.2  
**Upstream Views Physical Dimensions:** Is there any water present at this view? yes

If so, is there an obvious current? no

% of Channel Feature				
Riffle	0				
Run	0				
Pool	100

70% coverage of algae on substrate. Spike rush, and small willow along banks.

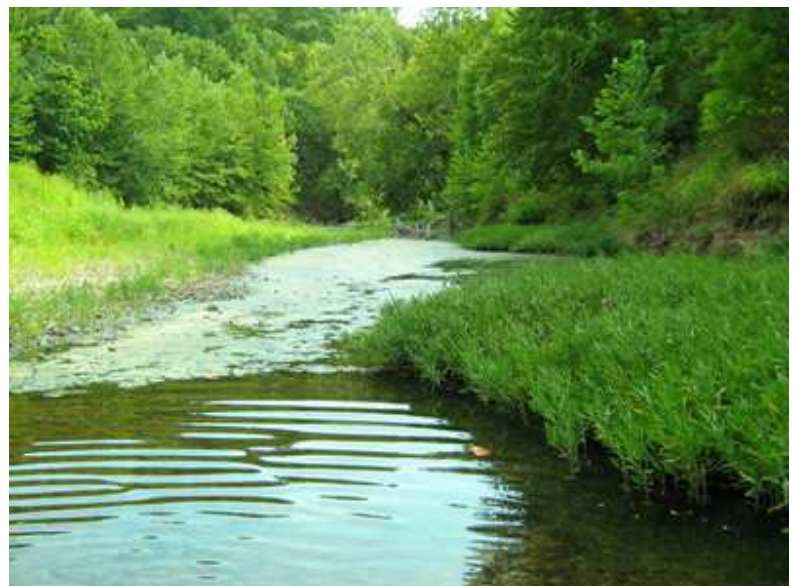
**Site# 2 Photo ID# 3, Downstream**

**Downstream View's Physical Dimensions:** Is there any water present at this view? yes

If so, is there an obvious current? no

% Cobble	% Gravel	% Sand	% Silt
18	35	12	24
% Mud/Clay	% Bedrock		
11	0

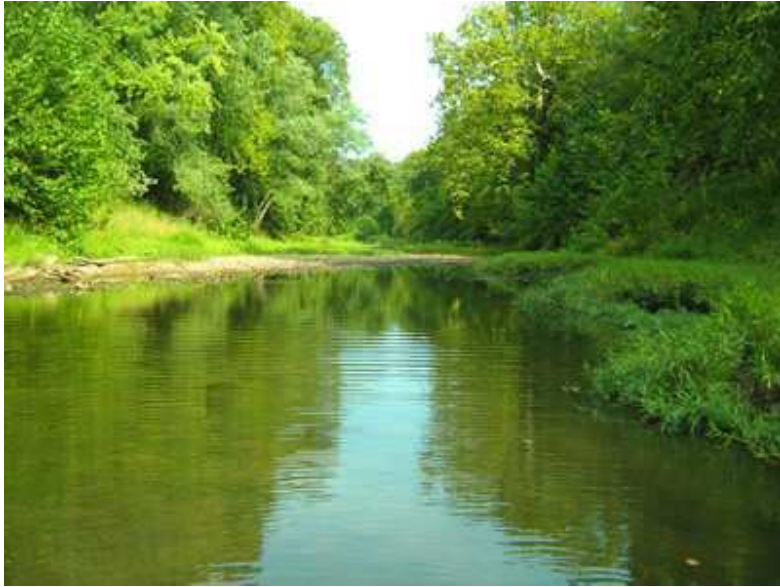
**Site# 3 Photo ID# 5, Upstream**

**WBID #** 737      **Site #** 3  
**Mark #** 78      **Dissolved Oxygen (ppm)** 7.8  
**Upstream Views Physical Dimensions:** Is there any water present at this view? yes

If so, is there an obvious current? no

% of Channel Feature				
Riffle	0				
Run	0				
Pool	100

Vegetation along banks (small willow, water primrose).

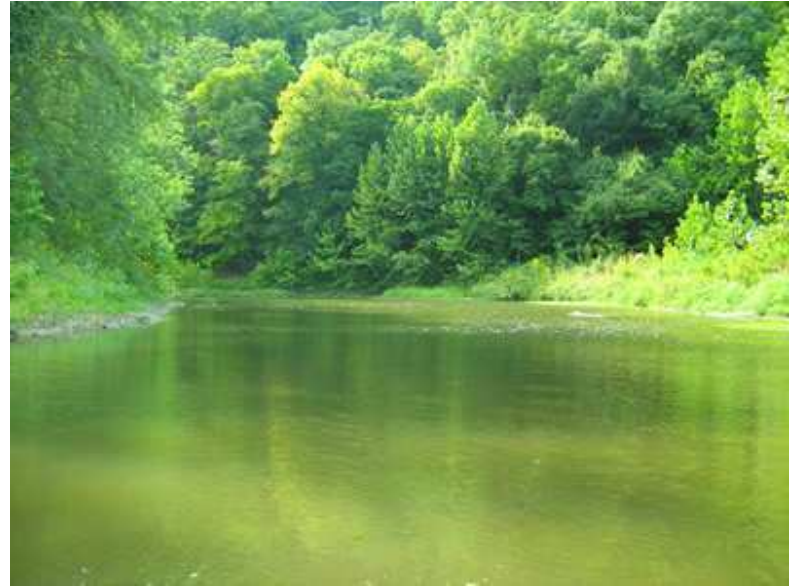
**Site# 3 Photo ID# 6, Downstream**

**Downstream View's Physical Dimensions:** Is there any water present at this view? yes

If so, is there an obvious current? no

% Cobble	% Gravel	% Sand	% Silt
24	29	14	33
% Mud/Clay	% Bedrock		
0	0

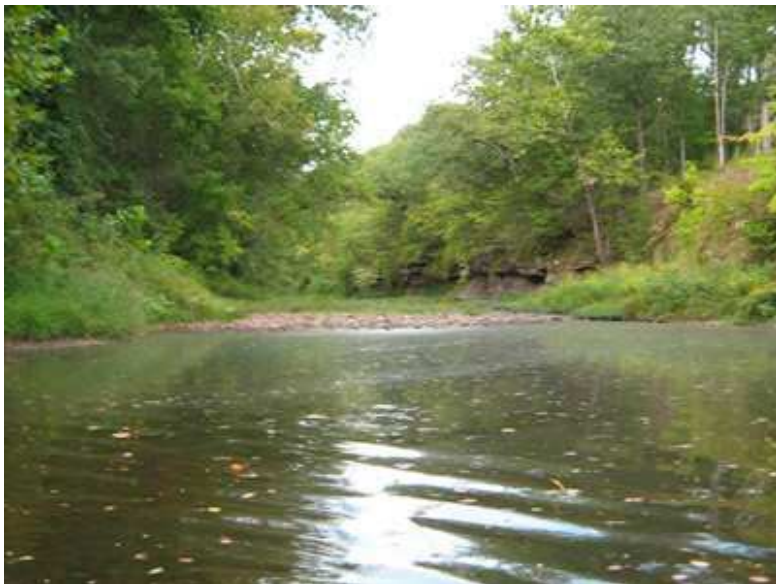
**Site# 4 Photo ID# 8, Upstream**

WBID # 737 Site # 4  
 Mark # 79 Dissolved Oxygen (ppm) 8.7  
 Upstream Views Physical Dimensions: Is there any water present at this view? yes

If so, is there an obvious current? no

% of Channel Feature				
Riffle	9				
Run					
Pool	91

grasses along banks, 10% algae bloom in stream.

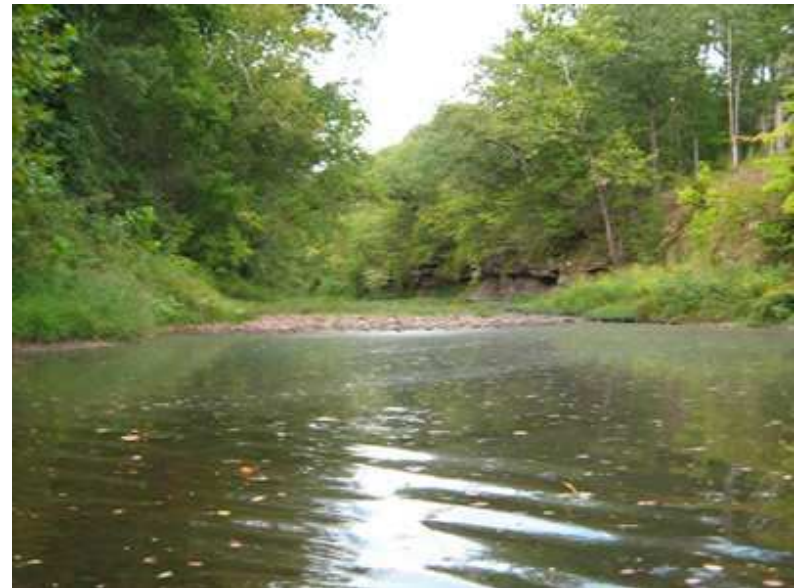
**Site# 4 Photo ID# 9, Downstream**

Downstream View's Physical Dimensions: Is there any water present at this view? yes

If so, is there an obvious current? no

18% Cobble	36% Gravel	14% Sand	9% Silt
------------	------------	----------	---------

% Mud/Clay	23% Bedrock
------------	-------------

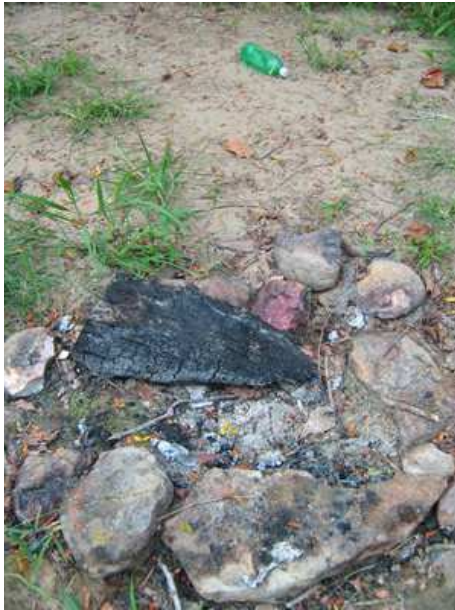
Roads	Rope swings	Foot paths/prints	Dock/platform
Livestock Watering	RV/ATV Tracks	Camping Sites	<b><u>Fire pit/ring</u></b> <b><u>picture 7</u></b>
NPDES Discharge	Fishing Tackle	Other:

**Site# 4 Photo ID# 7, Fire pit**

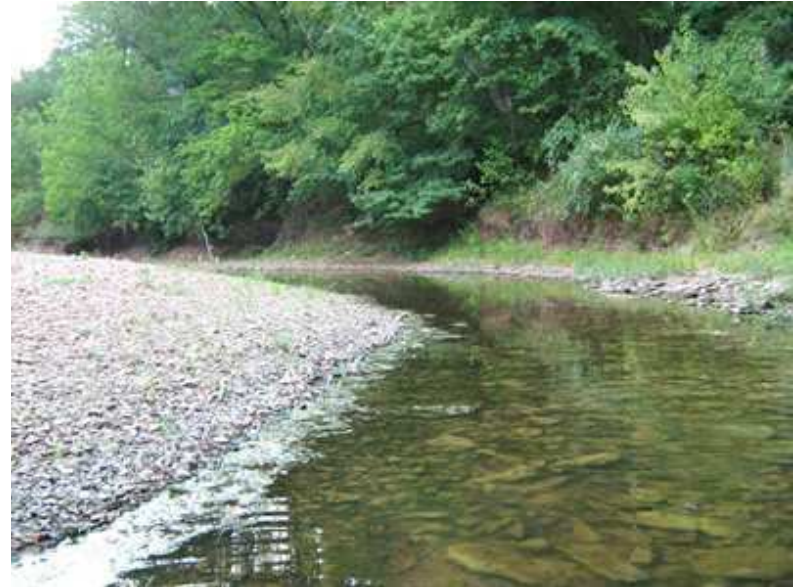
**Site# 5 Photo ID# 11, Upstream**

**WBID #** 737      **Site #** 5  
**Mark #** 80      **Dissolved Oxygen (ppm)** 6.7  
**Upstream Views Physical Dimensions:** Is there any water present at this view? yes

If so, is there an obvious current? no

% of Channel Feature				
Riffle	91				
Run	0				
Pool	9

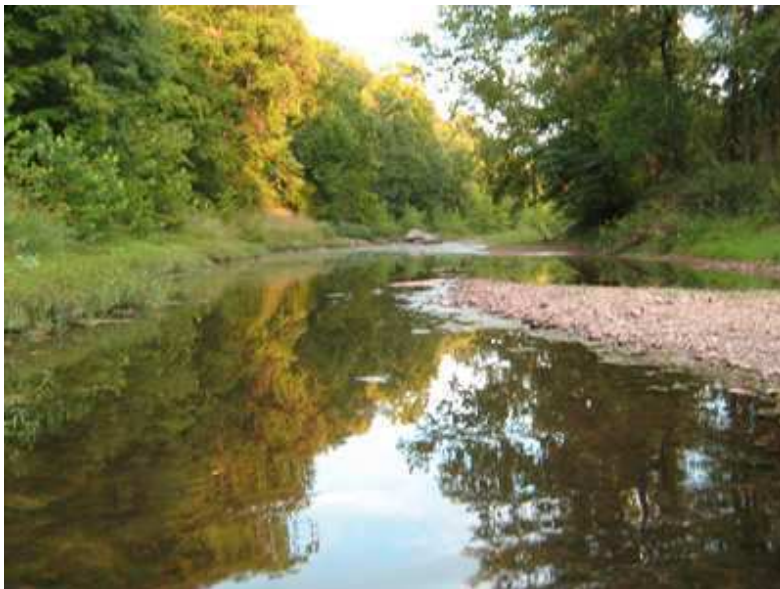
**Site# 5 Photo ID# 10, Downstream**

**Downstream View's Physical Dimensions:** Is there any water present at this view? yes

If so, is there an obvious current? no

100% Cobble	% Gravel	% Sand	% Silt
-------------	----------	--------	--------

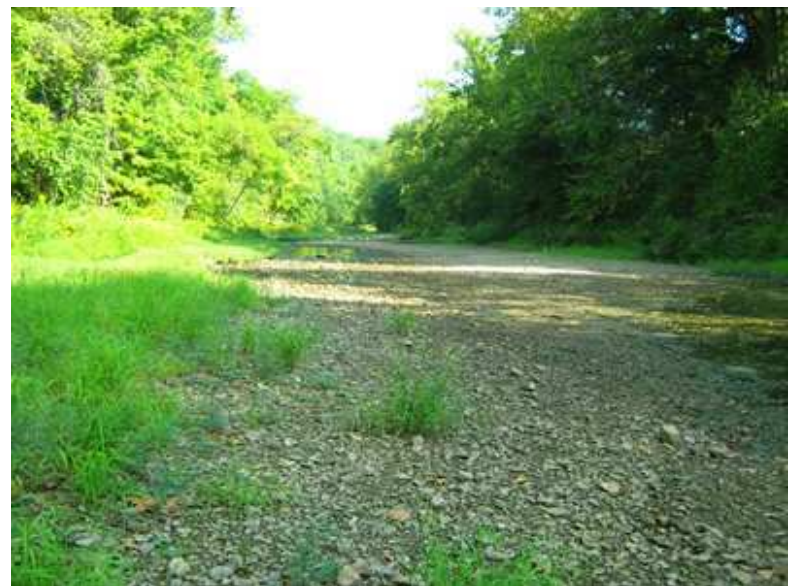
**Site# 6 Photo ID# 12, Upstream**

<b>WBID #</b>	737	<b>Site #</b>	6
<b>Mark #</b>	81	<b>Dissolved Oxygen (ppm)</b>	6.7
<b>Upstream Views</b>	<b>Physical Dimensions:</b>		Is there any water present at this view?      yes

If so, is there an obvious current? no

Riffle	27				
Run	0				
Pool	73

vegetation along banks, 20% small willow and algae blooms in stream

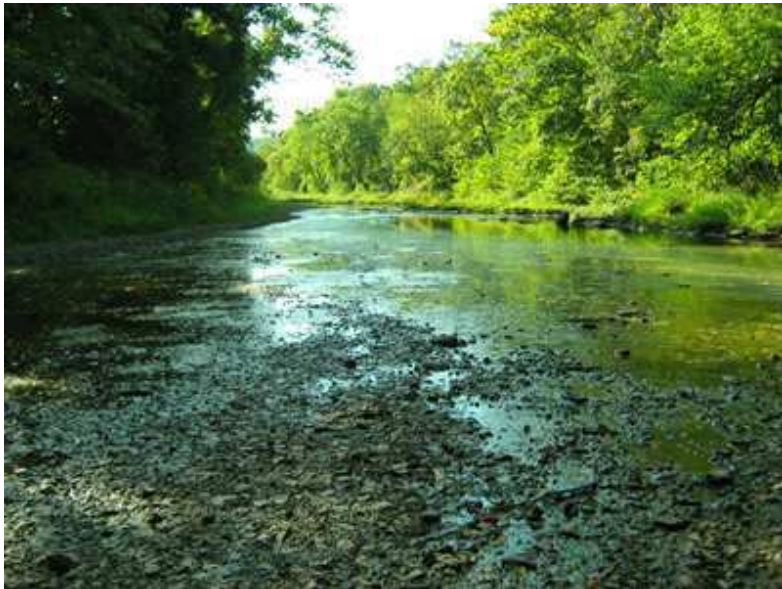
**Site# 6 Photo ID# 13, Downstream**

**Downstream View's Physical Dimensions:** Is there any water present at this view?      yes

If so, is there an obvious current? no

22% Cobble	73% Gravel	% Sand	% Silt
------------	------------	--------	--------

% Mud/Clay	5% Bedrock
------------	------------

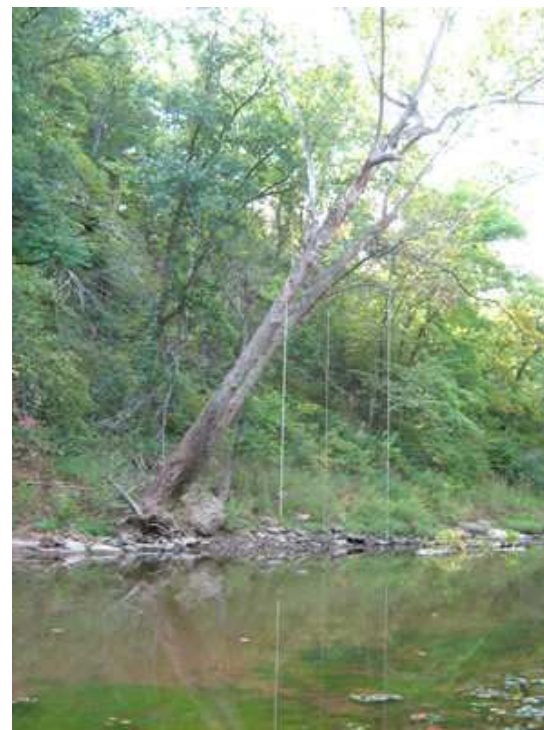
Roads	<u><b>Rope swings</b></u>	<u><b>Pic #15</b></u>	<u><b>Foot paths/prints</b></u>	Dock/platform
Livestock Watering	RV/ATV Tracks	<u><b>Camp Sites</b></u>	<u><b>Pic#16</b></u>	Fire pit/ring
NPDES Discharge	Fishing Tackle	<u><b>Other:</b></u>	<u><b>inflatable raft, Pic#14</b></u>

**Site# 6 Photo ID# 15, Rope swings**

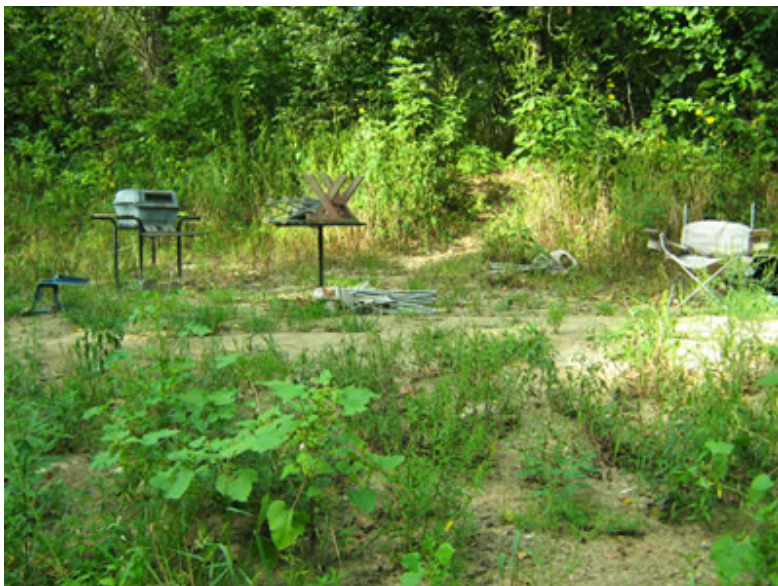
**Site# 6 Photo ID# 16, Camp sites**

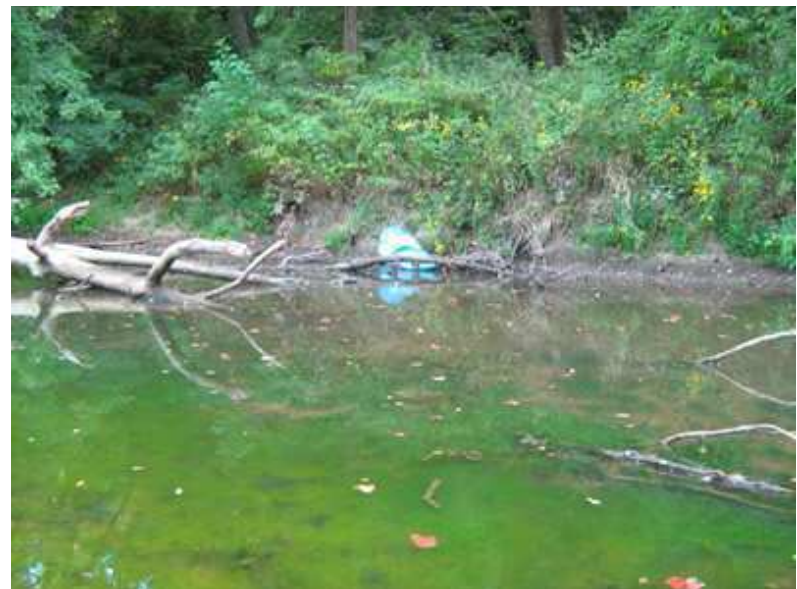
**Site# 6 Photo ID# 14, Inflatable raft**
